## Adventures with our Thermal Camera. January 2024

In this cold weather, we've been seeing what our Thermal Camera can tell us about where the heat is escaping from local homes. This helps inform discussion of what the options are to reduce heating and energy bills. People we've visited have found the images intriguing – sometimes they confirm the expected, sometimes there's a surprise.

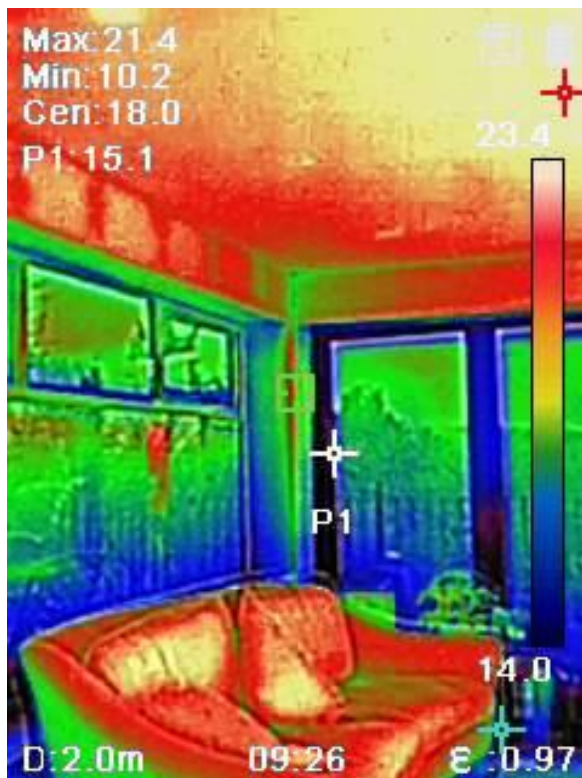
The camera certainly shows up how cold the edges of doors and windows can be – especially along the base. And especially along opening edges, where it's so hard to get a perfect seal.

*Cold edges to patio doors*

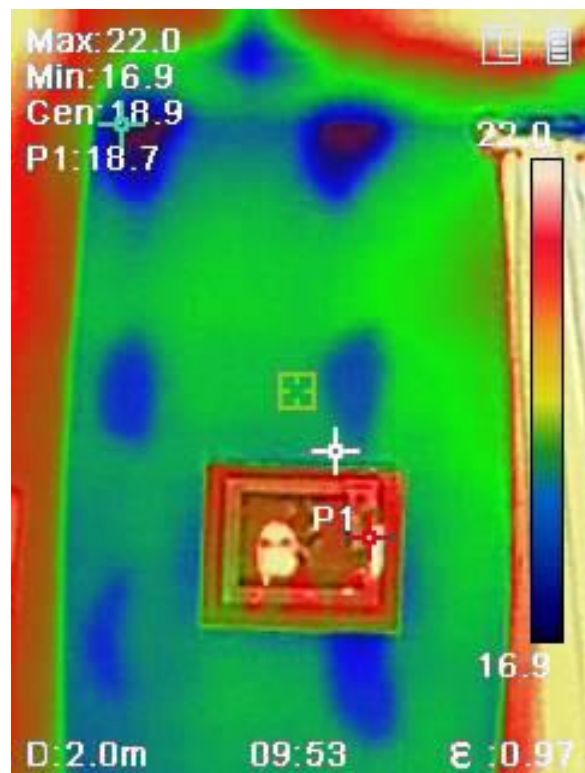
*Cement dabs used to fix plasterboard show up as colder than the rest of the wall*

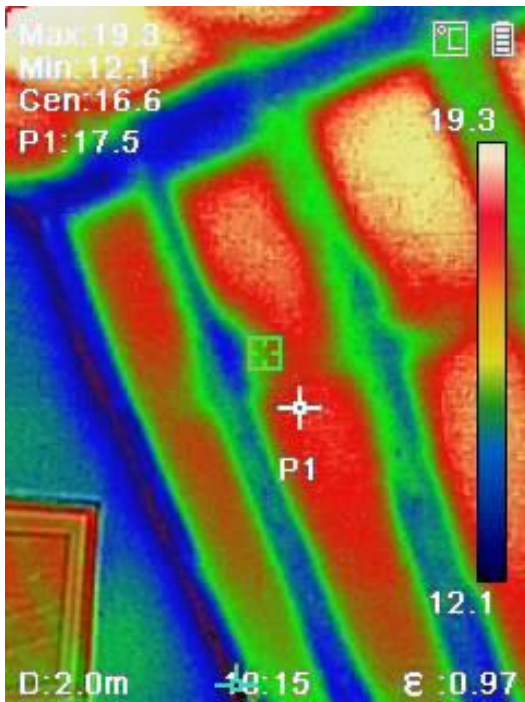
reason for the current recommendation, to add another layer above the rafters. The rafters let heat escape more than the rockwool, which creates cooler strips.

*Attic room: slope under the eaves showing rafters creating cold lines, with insulation between*

Loft insulation is one of the most cost-effective measures to take. Most people by now have a few inches between the rafters. What the camera has shown up is that there's a good

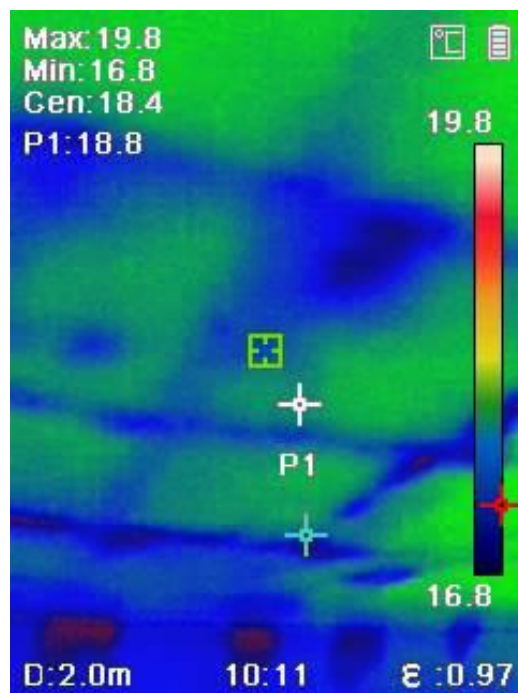
*Rafter pattern and cold spots show in thin roof insulation, and at top of wall*

The camera can help to spot whether insulation for different sections of wall and roof meet up properly. Cold spots often show up along wall corners, and outside top edges. These are the spots to watch for damp and condensation. (above, right)

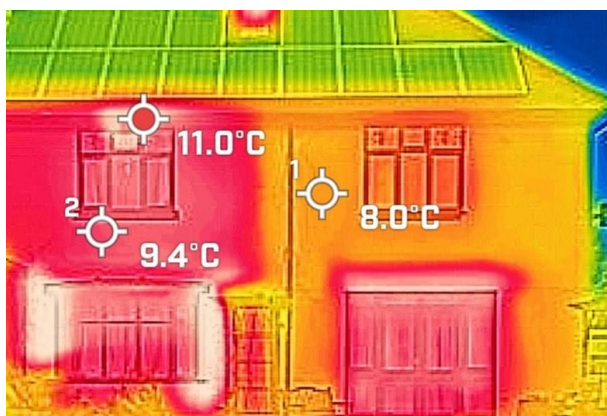
*From the outside: Left half is solid brick – losing heat fastest; right side is insulated cavity wall.*

Checking the house from the outside can highlight differences due to construction. The left side wall (above) is warmer than the right, because it's solid brick, and leaking more heat. Ornamental timber cladding in some homes had no bricks and little insulation behind it, creating a serious heat escape route.
